CANADIAN FORCES FLIGHT SAFETY INVESTIGATION (FSI) REPORT

FILE NUMBER: 1010-CT155202
DATE OF REPORT: 12 June 2007

AIRCRAFT TYPE: CT155 - Hawk
DATE/TIME: 142230Z (1630L) May 04
LOCATION: 15 Wing Moose Jaw, SK
CATEGORY: "A" Category Accident

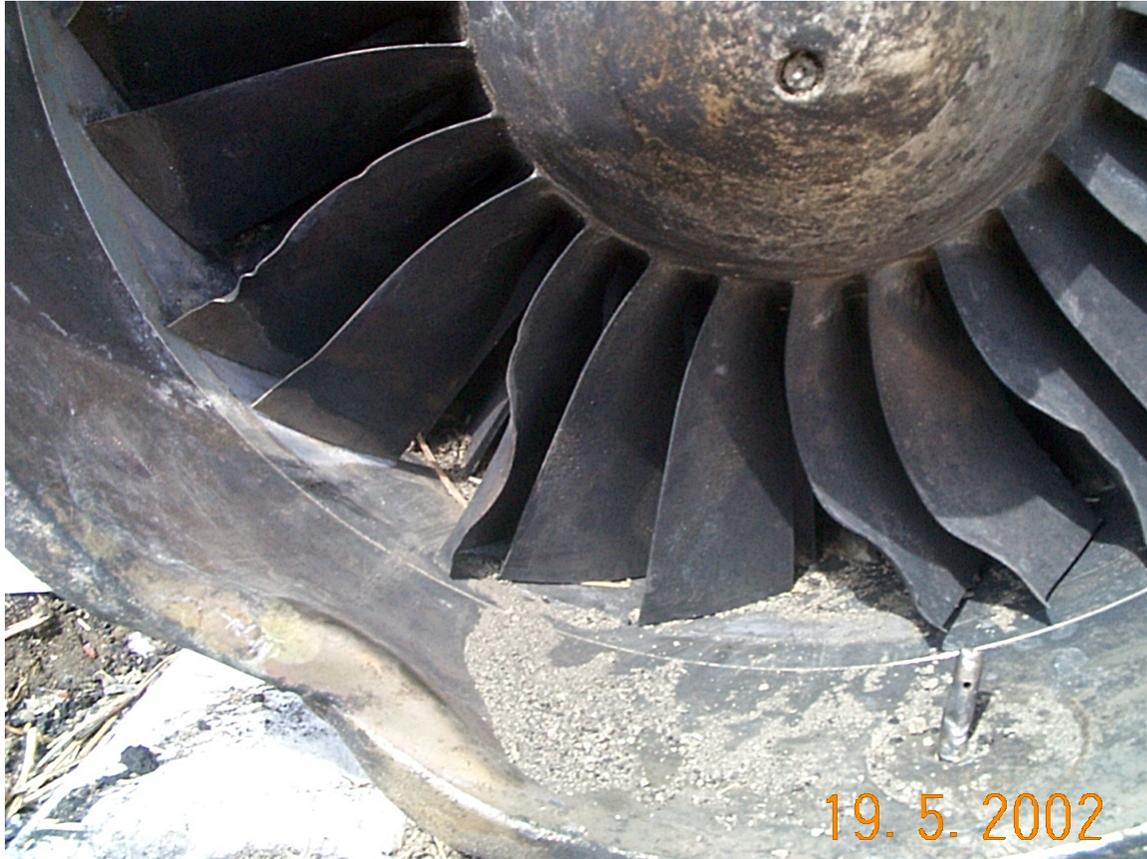
The Hawk Mk 115 is powered by the Adour Mk 871 turbofan engine with a 2-stage low-pressure compressor and a 5-stage high-pressure compressor. Examination of the low-pressure section showed soft FOD impact damage on up to four compressor blades, one isolated and three adjacent blades of the first stage compressor. (Photo 1) There was no indication that any of the first stage compressor blades were damaged enough for pieces to break off and to travel through the engine.

QETE analysis determined that the four damaged compressor blades had been drawn forward of their normal rotational plane at the position where the bird originally impacted. This bending was caused by the compressor trying to move a substance heavier than air rearwards through the compressor. There was also distortion to the airfoil for over 50% of the length of the four blades. The majority of the bird remains were directed through the bypass duct of the engine after passing through the low-pressure compressor. The remaining stages of the compressor section showed hard FOD damage that was most probably caused as the engine impacted the ground at low RPM. QETE concluded that the damage caused to the blades of the first stage compressor prevented the production of stable airflow that was necessary to firstly clear the stalled engine and then allow for a successful restart.

Photo 1 First Stage Compressor Damage

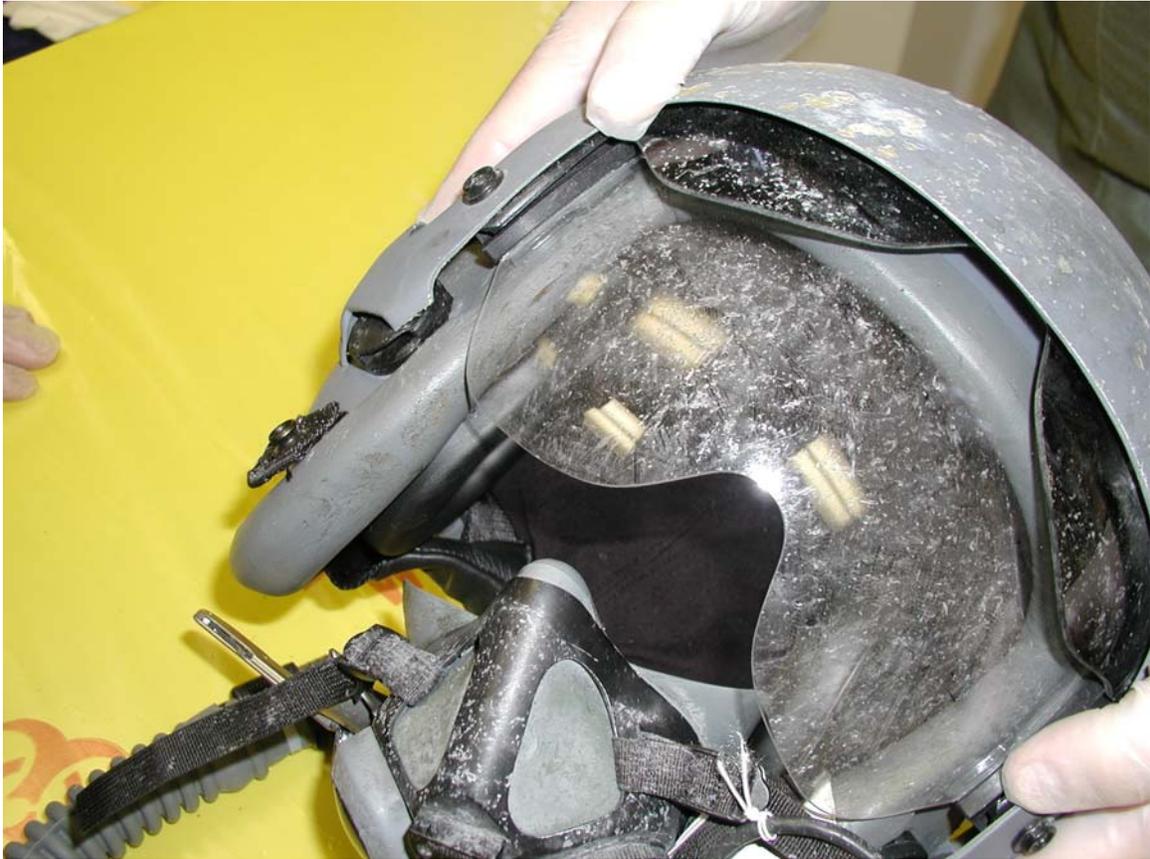
The CT155 canopy system uses Miniature Detonating Cord (MDC) to fracture the canopy during ejection. MDC is a lead sheathed detonating cord covered with a hard plastic layer, which is designed to fracture the canopy into small pieces prior to the seats being ejected from the aircraft. However, this system splatters very small but sharp particles throughout the cockpit area when it detonates, along with molten metal from the lead sheathed cord.

The MDC detonation in this ejection sequence resulted in burns to all exposed skin on the crew, and the particulates penetrated flying suits and undergarments, resulting in minor burns in some clothed areas.

Photo 2 **MDC Blast Damage**

4.2.4 The OAA ensure aircrew and support personnel are trained annually on safety precautions associated with MDC. Compliance with, and the monitoring of, these precautions must be continued. MDC splatter following its detonation represents a serious hazard to aircrew and ground crew during the ejection sequence and on the ground. Ground crew and aircrew should follow existing safety measures to minimize potential injuries. The need for aircrew to wear dual layer flying clothing and minimize exposed skin must be stressed.
